**SAFETY COMPLIANCE TESTING FOR FMVSS 201U**  
**Occupant Protection In Interior Impact**  
**Upper Interior Head Impact Protection**

**FUJI HEAVY INDUSTRIES, LTD.**  
**2005 Subaru Outback 4-Door Wagon**  
**NHTSA No. C55501**

**FINAL REPORT**

1. Report No. 201U-MGA-05-02		2. Government Accession No.		3. Recipient's Catalog No.	
4. Title and Subtitle Final Report of FMVSS 201U Compliance Testing of a 2005 Subaru Outback 4-Door Wagon, NHTSA No. C55501				5. Report Date December 3, 2004

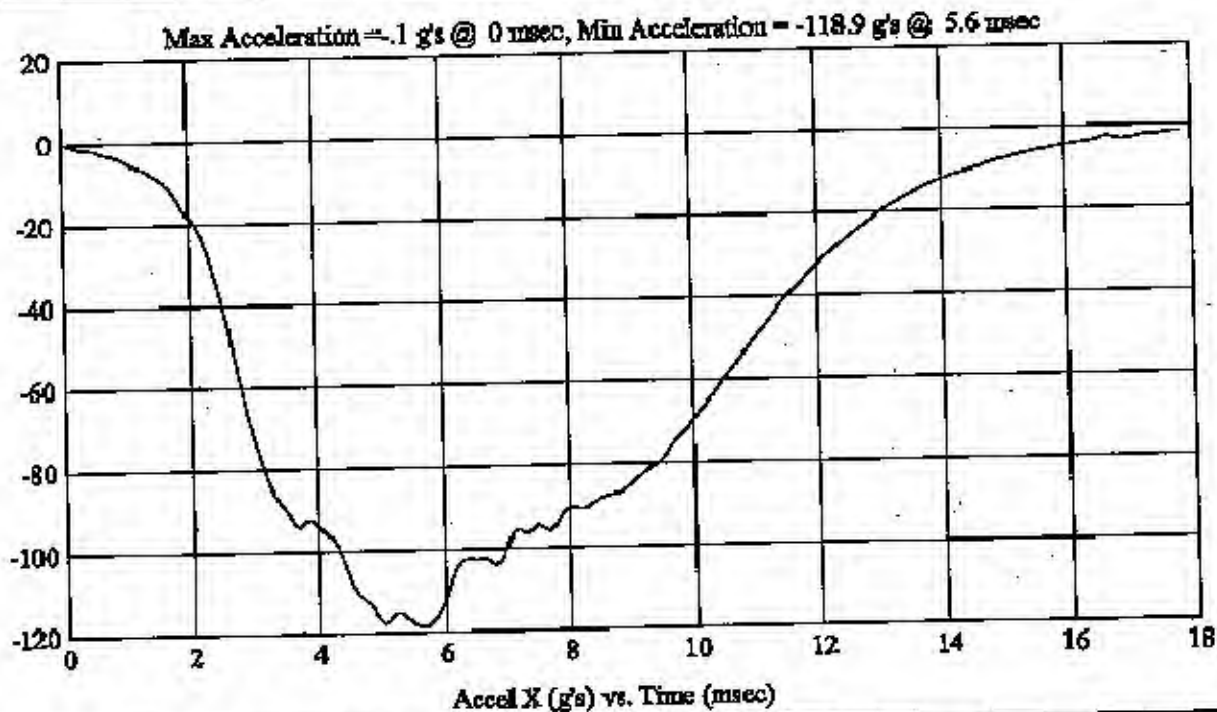
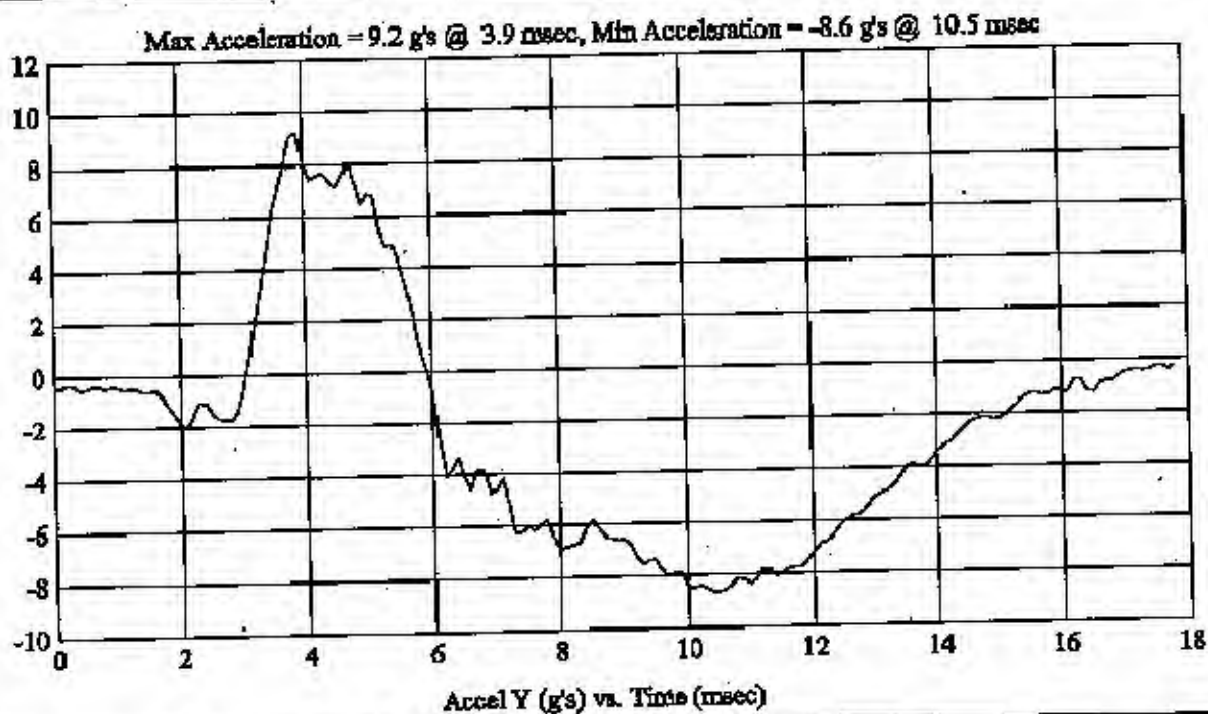
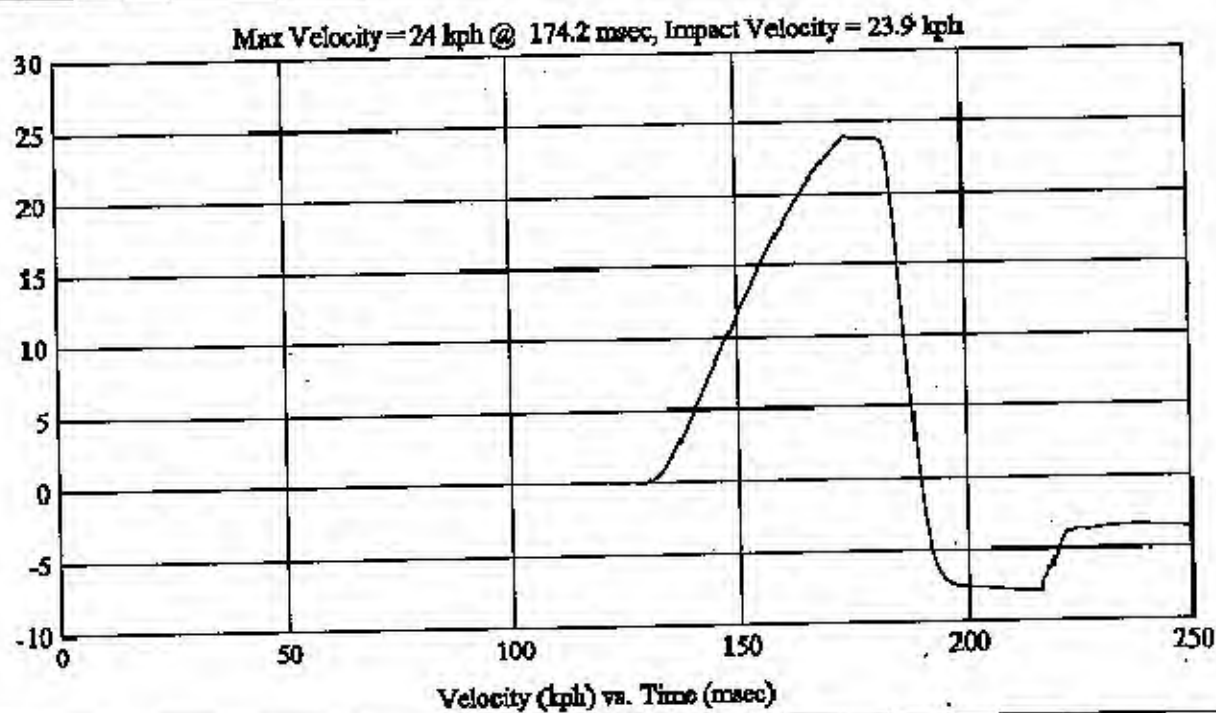
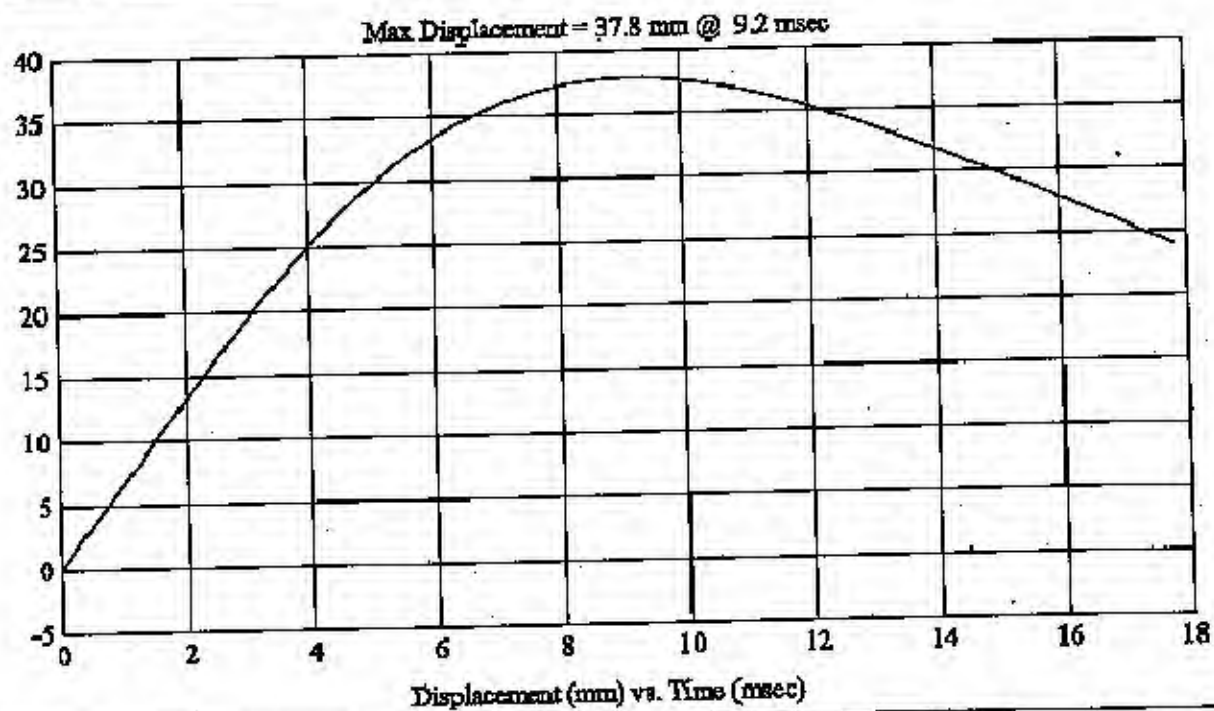
Grab Handle was broken off mount.

Model Year: 2005  
Target: UR6  
Vehicle Side: Right  
Horz/Vert Angle: 90/33

HIC(d) = 681, HIC = 683, Delta T = 8.3 msec
